OBJECT  
**CREATIVE CENTER  
 7 Dering Street, London**

NAME OF THE PROJECT:  
**Development of the Architecture design concept**

PROJECT: <b>CONCEPT DESIGN</b>	NUMBER OF THE PROJECT: 2019-IDR-A01
RECONSTRUCTION

PAGE CONTENT:  
**LOCATION PLAN**

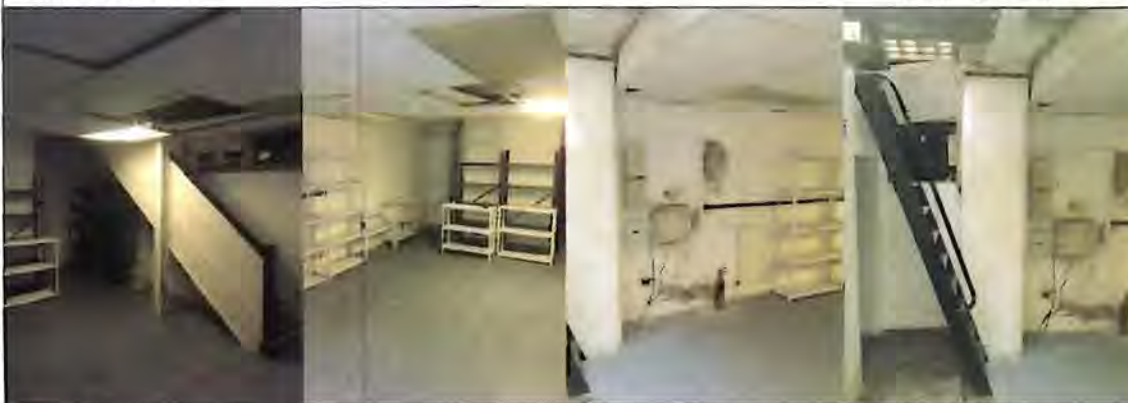
PHOTOS OF EXISTING STATE

Basement is used as storage for construction material, B contains utility room, kitchen, toilet room, shower room and storage rooms. The space is in very bad shape. The stairs are made of wood with vinyl plating on a wall. The floor is paved by ceramics and vinyl joints. Mortar surfaces are significantly damaged by capillary rising. Dropped ceiling, which is made of raster plates (Aluminum type) is continuously damaged by moisture. Electrical and plumbing installations have been repaired previously. Gas installations are made of copper pipes and go from the line of facade under the disposal ceiling in the kitchen and further vertically to the attic. Storage rooms (1 and 2) are made of laid bricks and coated with drainage foil in order to exclude the space from atmospheric water seepage. Storage block is covered with ceramics which was applied on to wooden slabs with vapour impermeable construction. Stairs made of wood are used as a fire escape to the street.

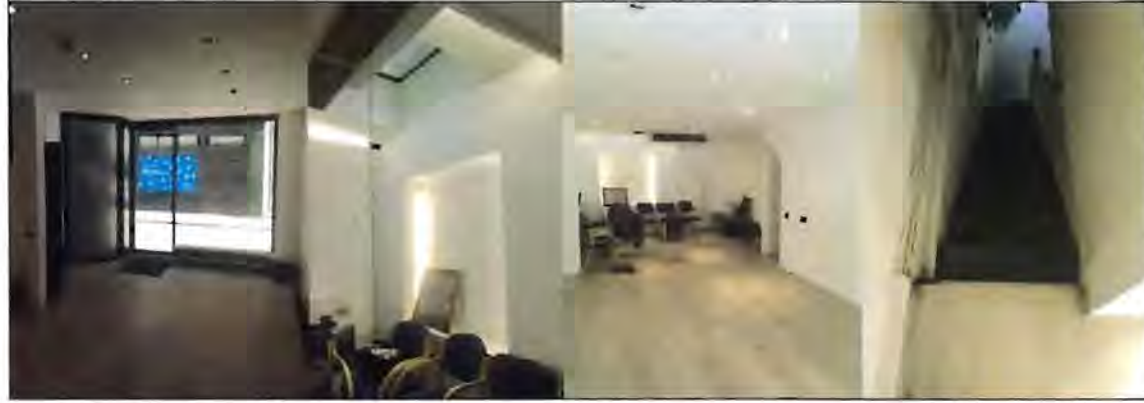
PHOTOS OF EXISTING STATE

**EXISTING FLOOR**  
Ground floor is used for exhibitions. The space for exhibitions has a lobby and a vertical communication - stairways, as well as a workshop at the entrance. The lobby is a glass partition. The floors are covered by laminate that is placed over stone tiles on a cement panel. All walls are covered by gypsum which is fixed to wooden construction that is an insulator based on the presence of cavity panels. The ceiling is made of drywall that have sound-absorbing and ventilation systems. The lobby is damaged by water leak in the area under the roof bottom. The ceiling of the hall roof with lantern is in poor condition, with degraded hydro insulation. The stairs are made of wood, with wooden treads and covered by carpet with battens. The lobby is made of wooden facade carpentry painted in dark tones and with of laminated glass. The capacity is 40 seats.

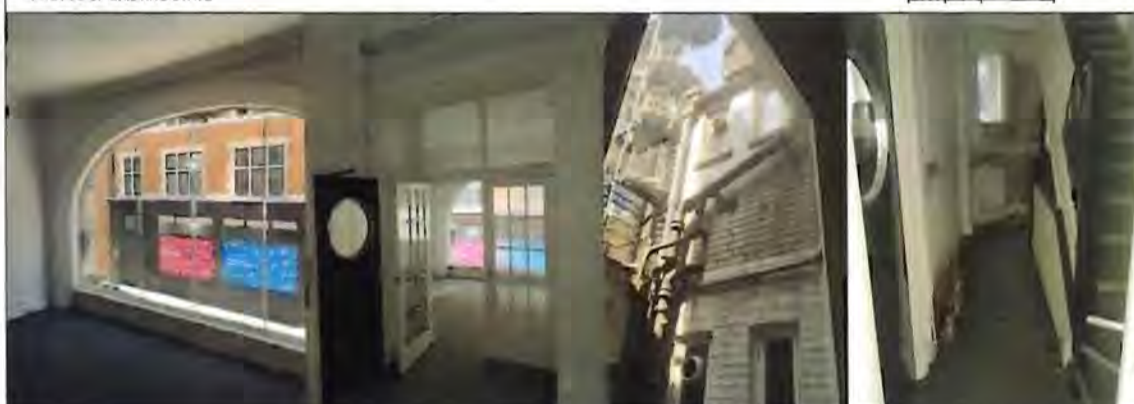
PHOTOS OF EXISTING STATE

**FIRST FLOOR**  
The first floor is used for exhibitions, it is composed of gallery, exhibition space, lobby and vertical communication - stairways and kitchenette. The space is in poor condition. The floors are paved by carpet that is placed on cement screed (in accordance with the instructions). The surface layer of carpet is damaged by water stains. The ceiling is made of wooden on the structural construction and decorative battens. The stairways are made of wood with wooden treads, and covered with carpet with battens. Carpentry is in poor condition. Rectangular lobby which is connected with the ground floor has wooden and metal carpentry made of wood and composite glass. The wood is damaged in dark areas. The lobby is in decorative condition.

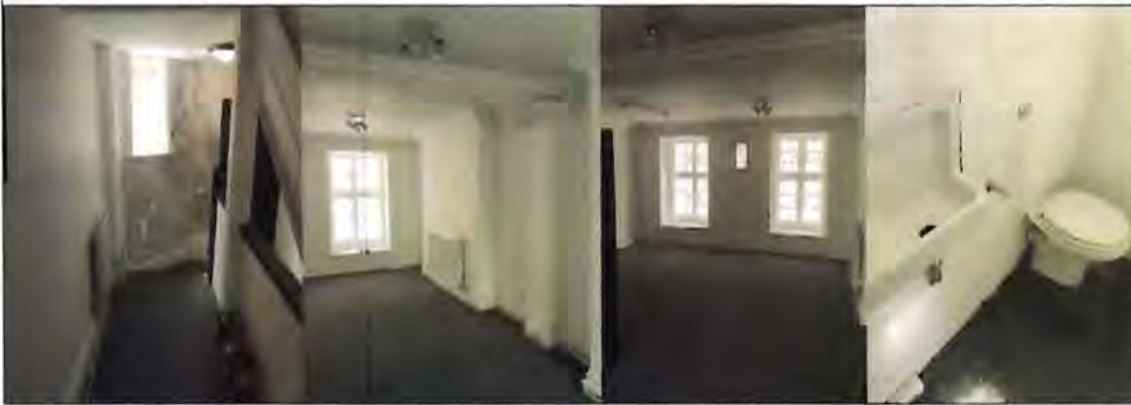
PHOTOS OF EXISTING STATE

Second floor is used as a working space. It consists of the working space, 4 PCs of toilet room, lobby and wooden communication. The toilet is in poor and depressing state. Ceiling is plaster over wooden floor. In the toilet room, vinyl plates are fixed to cement jacket. The surface of the toilet in the staircase area is considerably damaged showing signs of water stains. Whereas in other parts of the floor it is in good condition. The walls at most of lower part wooden construction and battens. There are marks of water, plaster with signs of battens. Entrance doorway is made of wood and metal and is very poor quality, however completely a made of wood.

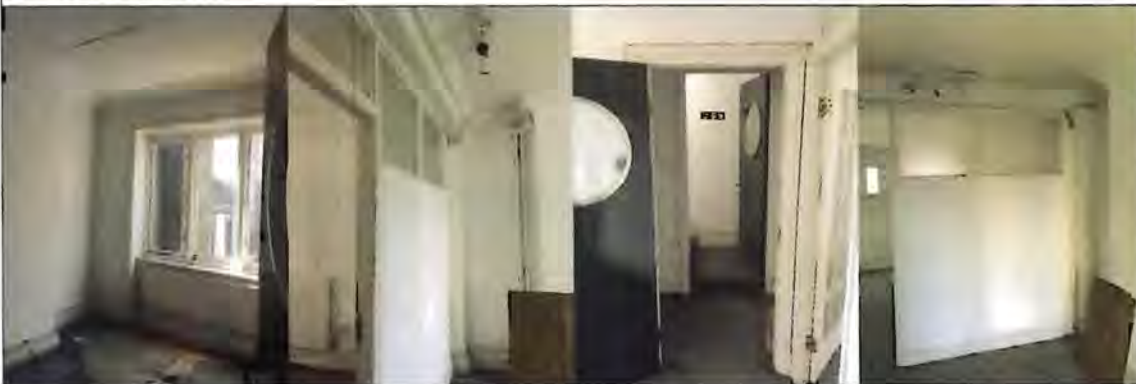
PHOTOS OF EXISTING STATE

This floor is used as a working space. In addition to the  
 working areas, it contains a lobby and a meeting  
 communication. The space is in poor condition. Floors  
 are covered by carpet on wooden beams. Walls are in  
 good condition. The ceiling is made of metal on  
 wooden construction. Staircase are made of wood and  
 covered with carpet with battens. Exterior and interior  
 casement is made of wood and metal. Both are in poor  
 shape.

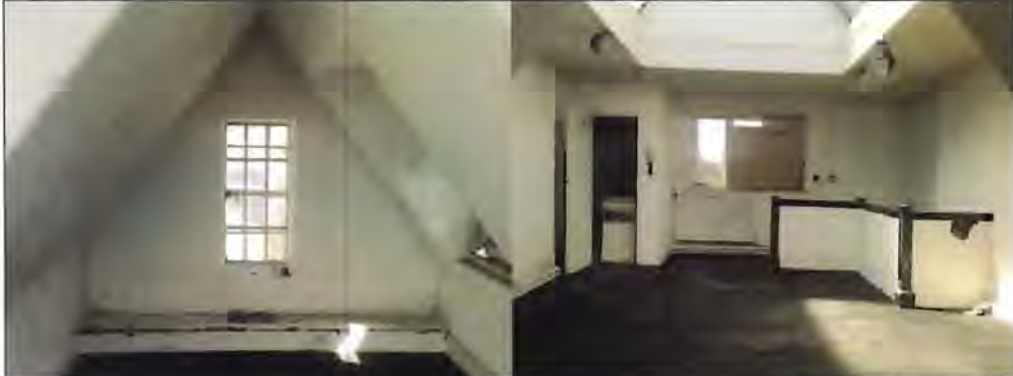
PHOTOS OF EXISTING STATE

A1.11:  
Atrio is used as a working space. It is composed of open working area and stairways. Atrio is on 3rd floor level. Floors are covered by carpet that is laid over wooden flooring. The surface of walls is in joint condition, with visible marks of water staining. Ceiling in the atrio is made of metal slatted into the wooden construction. Insulated roof has a glass lantern that is positioned above the centre of the atrio. Lantern is composed of steel frame with reinforced glass. The glass does not provide adequate heat and sound insulation. The roof is covered by fibrocement panels that are mounted onto wooden construction. Roof shows signs of water leak. Atrio and the roof space are connected. Heating system is placed in the atrio. The stairways are wooden, with wooden treads which are coated with carpet. Exterior canopy is made of wood and metal and it is in poor condition. Interior carpentry is made of wood and in bad shape.
