OBJECT  
**CREATIVE CENTER  
 7 Dering Street, London**

NAME OF THE PROJECT:  
**Development of the Architecture design concept**

PROJECT: <b>CONCEPT DESIGN</b>	NUMBER OF THE PROJECT: 2019-IDR-A01
RECONSTRUCTION

PAGE CONTENT:  
**LOCATION PLAN**

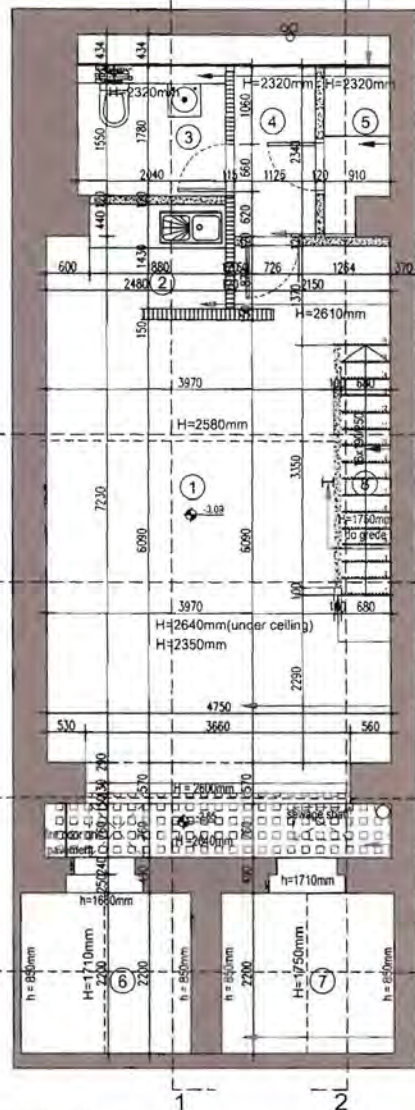
BASEMENT

Toilet room description:  
ceramics on the floor, walls and ceiling plaster and painted in white

Shower cabin description:  
ceramics on the floor and on the walls, placed to the full height of the room 2320mm, ceiling plaster and painted in white

Stairs description:  
wooden staircase 16x 190/250mm, wooden tread with vinyl plates in anthracite color, with stripes

Storage description:  
vinyl records on the floor, walls and ceiling are made of laid bricks and coated with drainage foil

Basement is used as storage for construction material, B contains utility room, kitchen, toilet room, shower room and storage rooms. The space is in very bad shape. The stairs are made of wood with vinyl plating on a wall. The floor is paved by ceramics and vinyl joints. Mortar surfaces are significantly damaged by capillary rising. Dropped ceiling, which is made of raster plates (Aluminum type) is continuously damaged by moisture. Electrical and plumbing installations have been repaired previously. Gas installations are made of copper pipes and go from the line of facade under the disposal ceiling in the kitchen and further vertically to the attic. Storage rooms (1 and 2) are made of laid bricks and coated with drainage foil in order to exclude the space from atmospheric water seepage. Storage block is covered with ceramics which was applied on to wooden slabs with vapour impermeable construction. Stairs made of wood are used as a fire escape to the street.

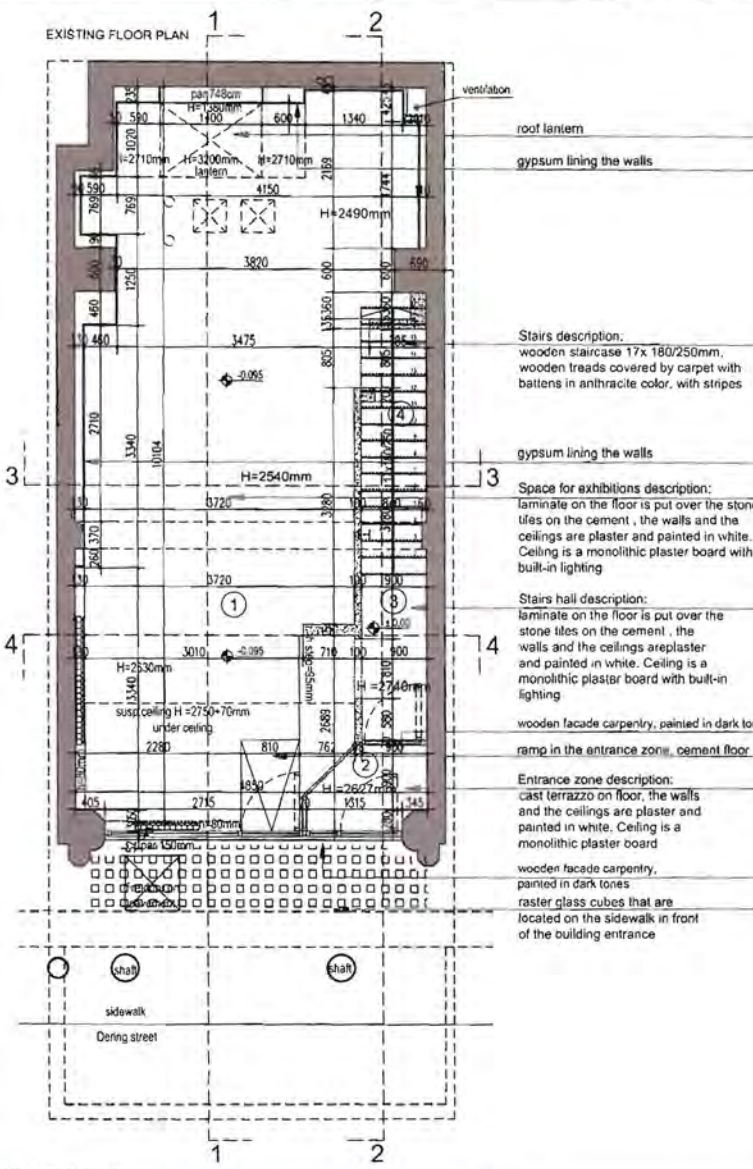
EXISTING FLOOR PLAN

**Space for exhibitions description:**  
laminat on the floor is put over the stone tiles on the cement, the walls and the ceilings are plaster and painted in white. Ceiling is a monolithic plaster board with built-in lighting

**EXISTING FLOOR**  
Ground floor is used for exhibitions. The space for exhibitions has a lobby and a vertical communication - stairways, as well as a workshop at the entrance. The lobby is a glass partition. The floors are covered by laminate that is placed over stone tiles on a cement panel. All walls are covered by gypsum which is fixed to wooden construction that is an insulator based on the presence of cavity panels. The ceiling is made of drywall that have sound-absorbing and ventilation systems. The lobby is damaged by water leak in the area under the roof bottom. The ceiling of the hall roof with lantern is in poor condition, with degraded hydro insulation. The stairs are made of wood, with wooden treads and covered by carpet with battens. The lobby is made of wooden facade carpentry painted in dark tones and with of laminated glass. The capacity is 40 seats.

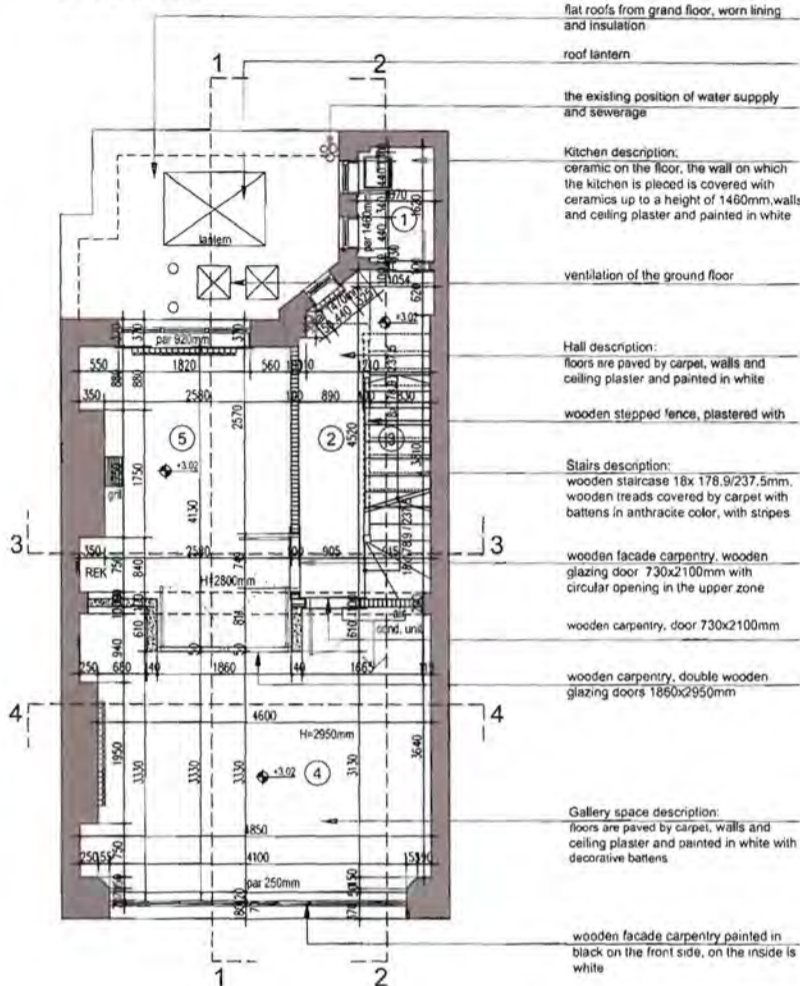
EXISTING FLOOR PLAN

- flat roofs from grand floor, worn lining and insulation
- roof lantern
- the existing position of water supply and sewerage
- Kitchen description:  
ceramic on the floor, the wall on which the kitchen is placed is covered with ceramics up to a height of 1460mm, walls and ceiling plaster and painted in white

**FIRST FLOOR**  
The first floor is used for exhibitions, it is composed of gallery, exhibition space, lobby and vertical communication - stairways and kitchenette. The space is in poor condition. The floors are paved by carpet that is placed on cement screed (in accordance with the instructions). The surface layer of carpet is damaged by water stains. The ceiling is made of wooden on the structural construction and decorative battens. The stairways are made of wood with wooden treads, and covered with carpet with battens. Carpentry is in poor condition. Rectangular lobby which is connected with the ground floor has wooden and metal carpentry made of wood and composite glass. The wood is damaged in dark areas. The lobby is in decorative condition.

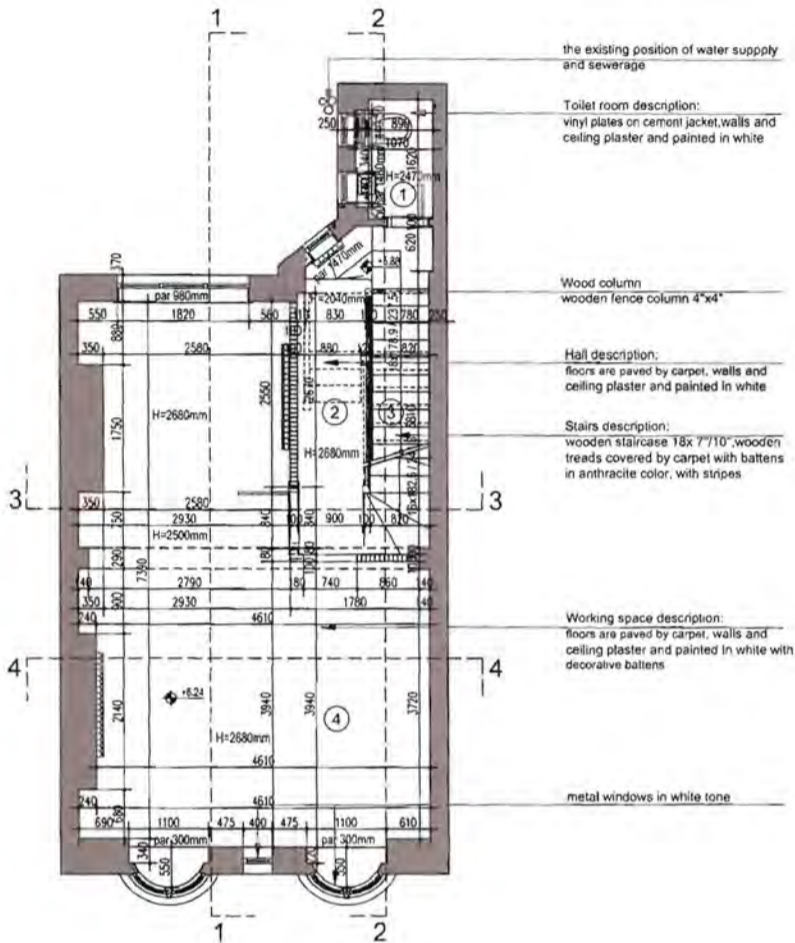
EXISTING FLOOR PLAN

Second floor is used as a working space. It consists of the working space, 4 PCs of toilet room, lobby and wooden communication. The toilet is in poor and depressing state. Ceiling is plaster over wooden floor. In the toilet room, vinyl plates are fixed to cement jacket. The surface of the toilet in the staircase area is considerably damaged showing signs of water stains. Whereas in other parts of the floor it is in good condition. The walls at most of lower part wooden construction and battens. There are marks of water, plaster with signs of battens. Entrance doorway is made of wood and metal and is very poor quality, however completely a made of wood.

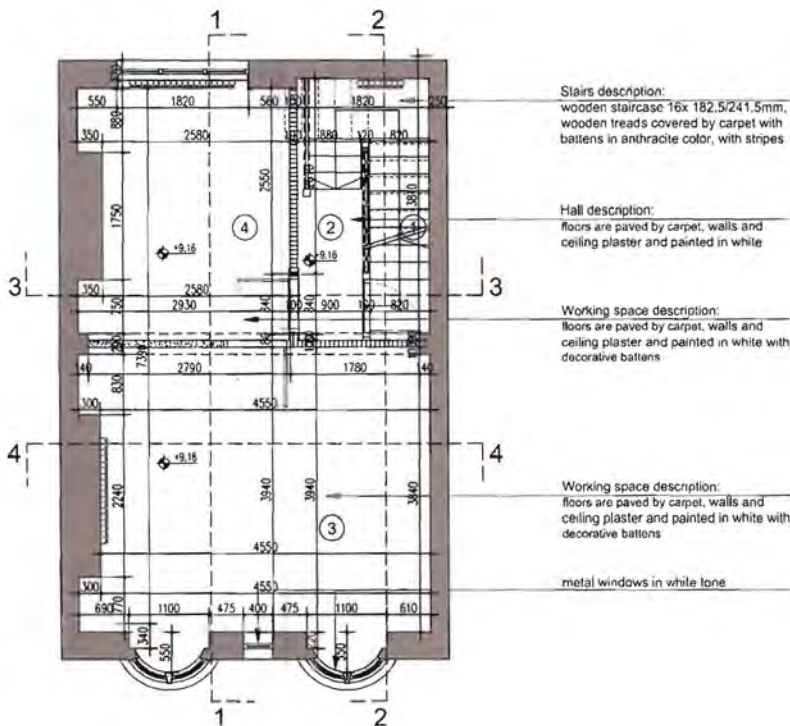
This floor is used as a working space. In addition to the  
 working areas, it contains a lobby and a meeting  
 communication. The space is in poor condition. Floors  
 are covered by carpet on wooden beams. Walls are in  
 good condition. The ceiling is made of metal on  
 wooden construction. Staircase are made of wood and  
 covered with carpet with battens. Exterior and interior  
 casement is made of wood and metal. Both are in poor  
 shape.

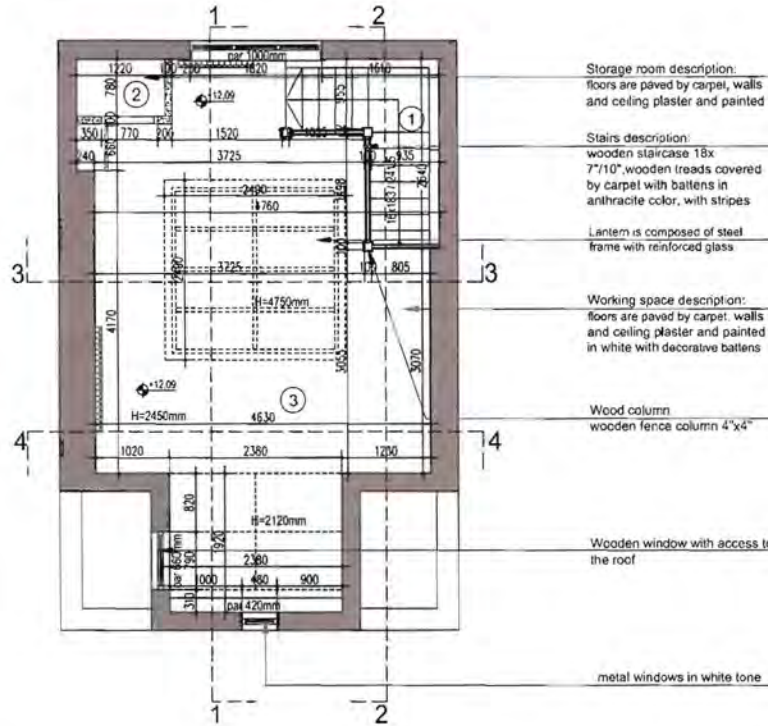
- Storage room description:  
floors are paved by carpet, walls and ceiling plaster and painted
- Stairs description:  
wooden staircase 18x 7"/10", wooden treads covered by carpet with battens in anthracite color, with stripes
- Lantern is composed of steel frame with reinforced glass
- Working space description:  
floors are paved by carpet, walls and ceiling plaster and painted in white with decorative battens
- Wood column  
wooden fence column 4"x4"
- Wooden window with access to the roof
- metal windows in white tone

A1.11:  
Atrio is used as a working space. It is composed of open working area and stairways. Atrio is on 3rd floor level. Floors are covered by carpet that is laid over wooden flooring. The surface of walls is in joint condition, with visible marks of water staining. Ceiling in the atrio is made of metal slatted into the wooden construction. Insulated roof has a glass lantern that is positioned above the centre of the atrio. Lantern is composed of steel frame with reinforced glass. The glass does not provide adequate heat and sound insulation. The roof is covered by fibrocement panels that are mounted onto wooden construction. Roof shows signs of water leak. Atrio and the roof space are connected. Heating system is placed in the atrio. The stairways are wooden, with wooden treads which are coated with carpet. Exterior canopy is made of wood and metal and it is in poor condition. Interior carpentry is made of wood and in bad shape.
